The Restoration of the Fortepiano by Nannette Streicher Opus 961, Vienna 1813 (SAM 844)

Ina Hoheisel and Alfons Huber

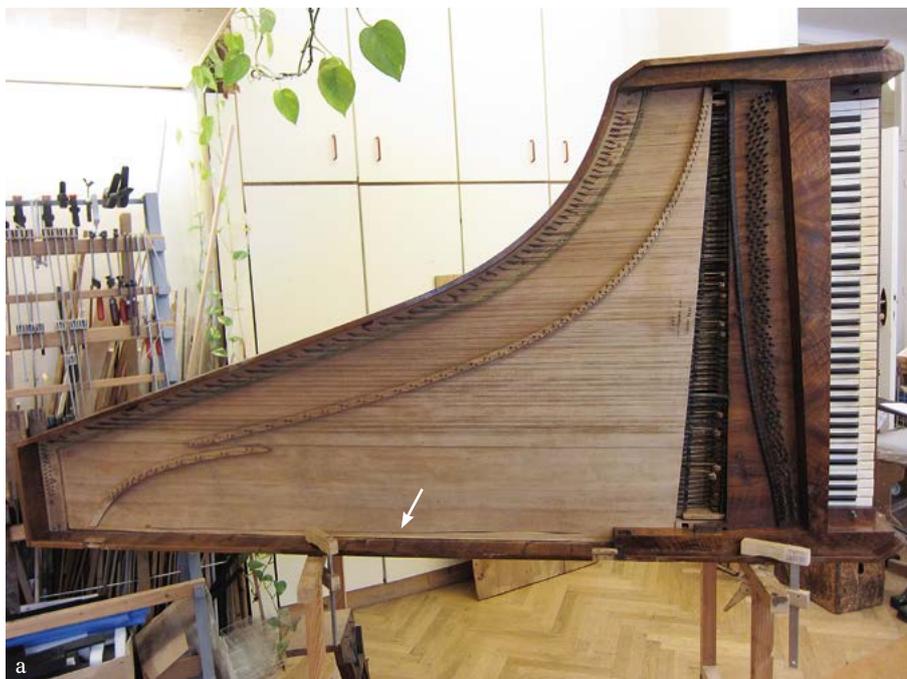
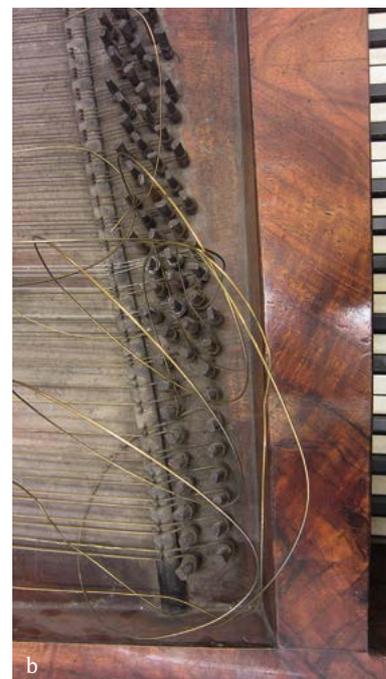
Fig. 3: Condition before treatment 2013.

a. Compression crack in the long wall.

b. Inhomogeneous appearance with corroded and broken strings.

In 2013, the instrument was in a badly damaged, partially altered and modified, unplayable state (*fig. 3*). The goal of the conservation and restoration measures was only partially clear at the start, so that for documentation purposes and in-depth examination a technical, 1:1 hand drawing of the entire instrument was first made (*fig. 4*).²

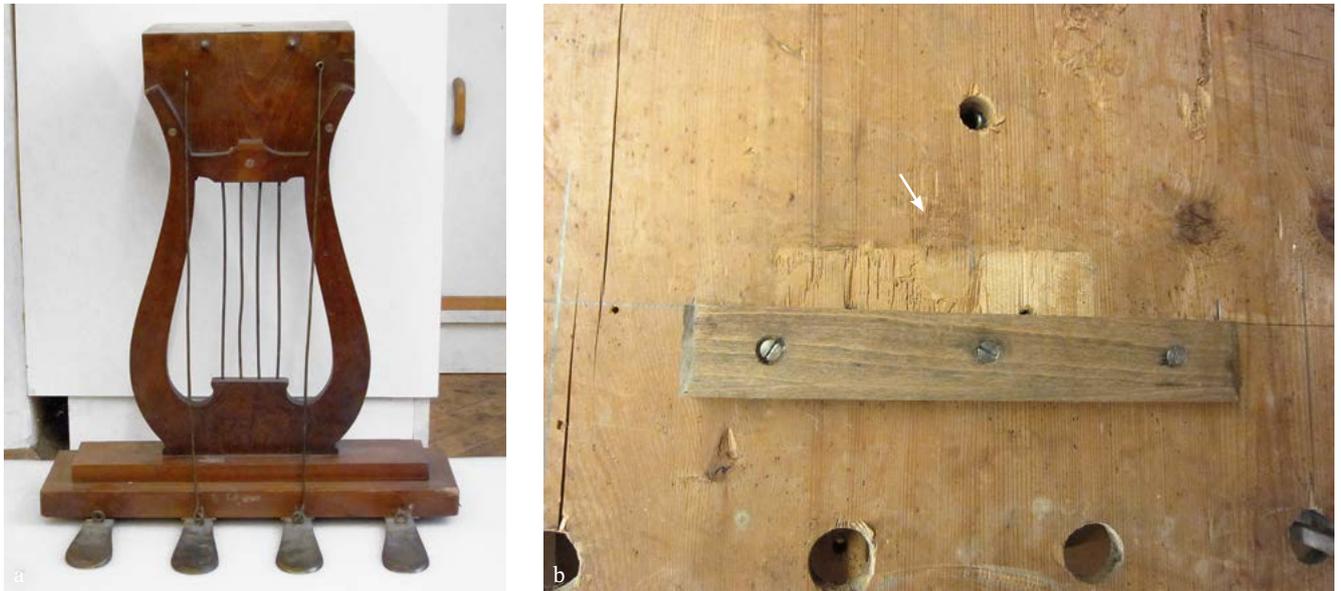
Fig. 5: Rebuilt pedal system (2nd half of the 19th century).
a. Original lyre on new pedal bar.
b. Traces of the original mounting of the lyre.

One of the at first glance most visibly disturbing changes lay in the alteration of the original pedal system, in which, likely in the second half of the nineteenth century, the original lyre was screwed to a new construction. The original wooden pedals were replaced by pedals of brass and screwed with a new mounting to the underside of the piano, where the traces of the original lyre attachment were still visible (*fig. 5*).

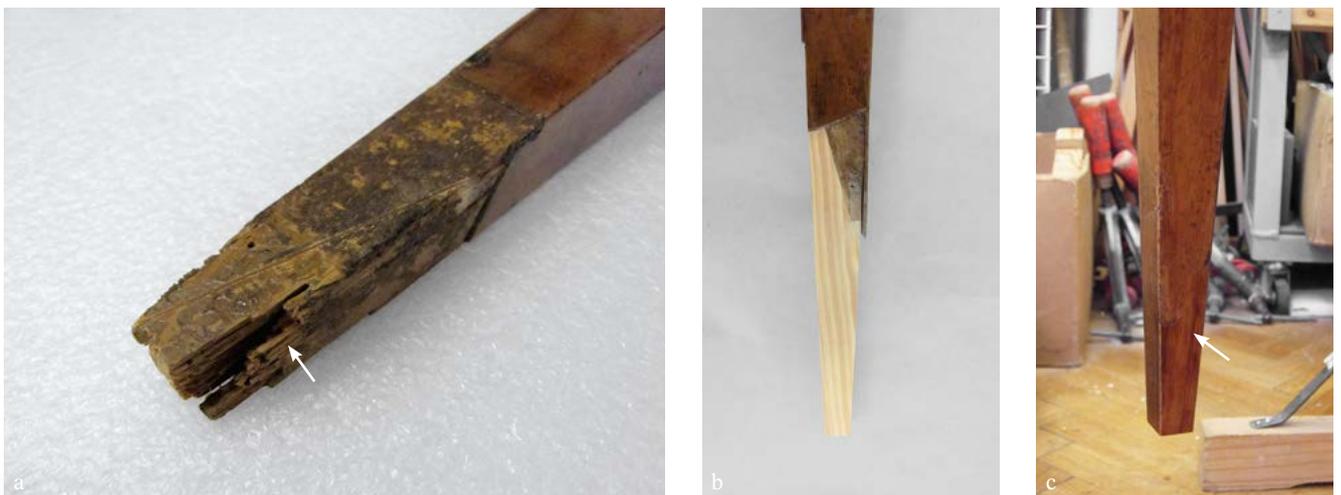
Fig. 6: Creating stability.
a. Leg damaged by furniture beetle activity.
b. Repair of the worm-damaged foot.
c. Veneer compensation with old veneer.

Due to the fact that one leg was missing and two legs were damaged by furniture beetle activity, the piano could not be placed on its feet. That, however, was a prerequisite for the reconstruction of the pedal system, or rather of the length of the activating wires. As the wood core of one leg was crushed and broken away through insect holes, this had to be replaced with new wood. The visible surfaces were closed through loss-free compensation using old, already lacquered veneer, which proved advantageous as the

surface was aged and bore traces of use, and thus matched the overall appearance of the instrument (*fig. 6*). The piano surely had a curved pedal bar originally. Two sibling instruments were found for comparison, in the Swedish Museum of Performing Arts in Stockholm from 1814 (*fig. 7a*) and the Vienna Museum of Technology from 1819 (*fig. 7b*). Two facts are evident from these comparison instruments:

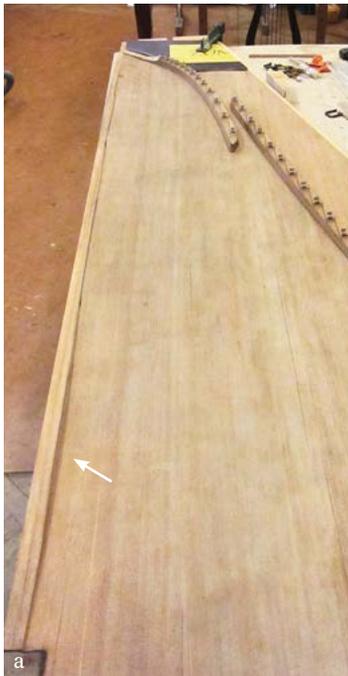
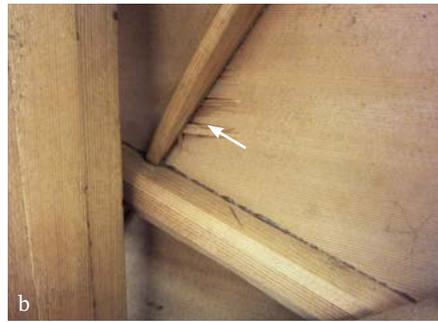
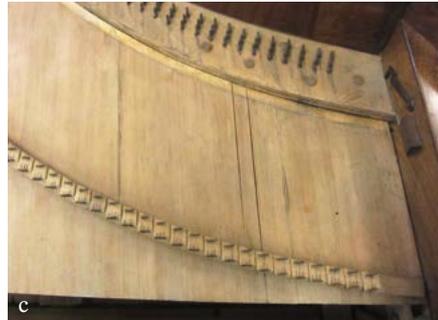
Fig. 8: Damage to the soundboard.
a. Compression crack on the long wall.
b. Detached ribs.
c. Shrinkage cracks in the treble.

The soundboard displayed multiple shrinkage cracks, loose ribs, deformations, and a typical compression crack along the long wall, which was caused by excessive tension and the detached bass hitchpin rail (*fig. 8*).

A plywood sheet was prepared with holes cut for the bridges to be able to lay the soundboard upside down. The ribs – if the adhesion had not already failed in the past – were 2/3 detached to relax the soundboard. Through underlaying the outer edges of the soundboard with strips of fabric and placing warm sandbags on the distorted areas, a return to plane could be achieved. Further, all open cracks were repaired and the considerable shrinkage compensated for through the insertion of strips of new soundboard wood in the treble area. The long crack along the long wall was glued in stages.

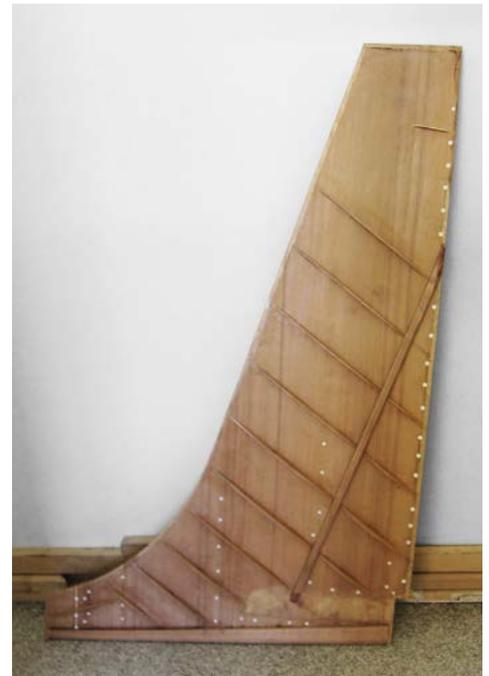
Fig. 9: Restoration of the soundboard, securing cracks with pieces of parchment.

After the reduction of deformations to the soundboard and gluing of all ribs to the pre-dried soundboard, the joints and crack edges were secured from the bottom with small pieces of pre-dried parchment (*fig. 9*), before the soundboard was glued back into the instrument.

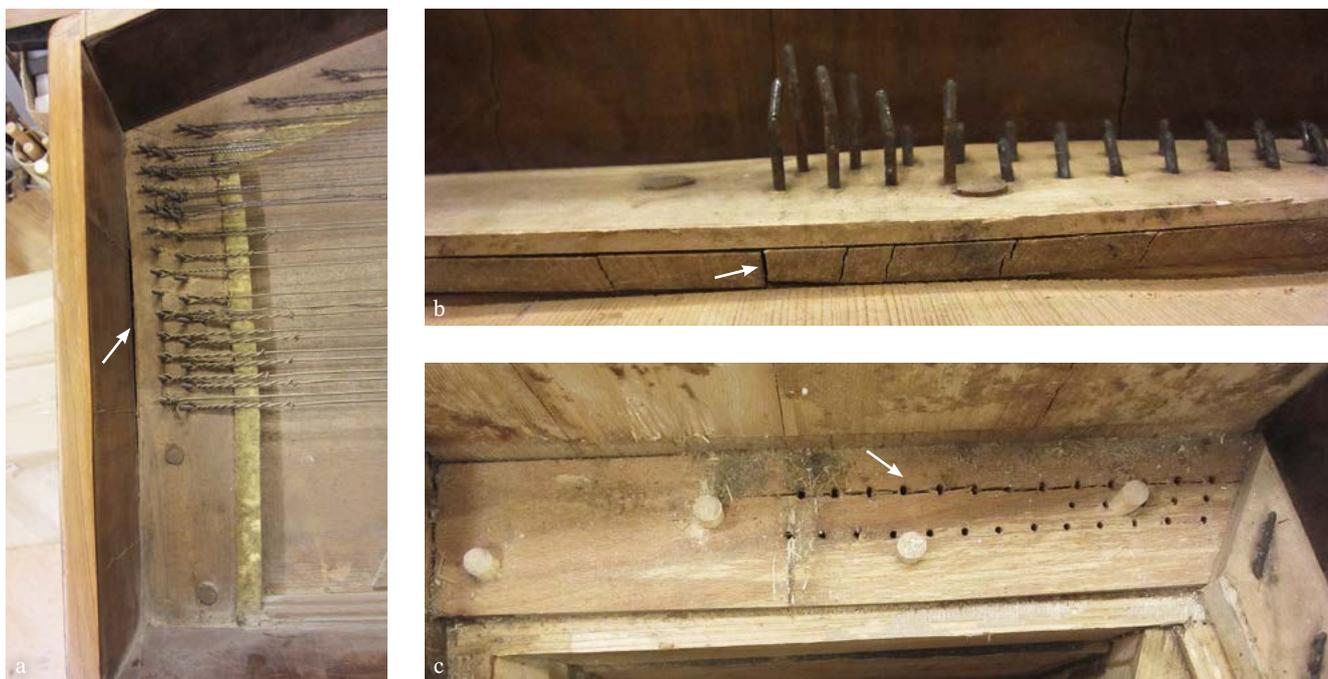
Fig. 10: Damage to the bass hitchpin rail.

a. Detached, deformed bass hitchpin rail.

b and c. The wood of the second and third layers is incorrectly oriented and cracked along the main cleavage direction.

Through the later restringing of the instrument with strings that were much too strong – this will be discussed later in more detail – a tension of around 6,000 N (equivalent to about 600 kg) bore on the bass hitchpin rail alone. This hence detached from the back wall and distorted. On the hitchpin rail, constructed in three layers, the layers had separated, which due to the inauspicious wood choice in its creation were multiply cracked and thus no longer functional (*fig. 10*).

As for layers 2 and 3, the main split direction of the wood lay parallel to the plate pins – which caused the present crack formation and would have resulted in further cracks – it was decided, against usual museum conventions, to replace these two layers for static reasons. With the removal of deformations and adhesion of the upper layer, the original appearance was preserved.

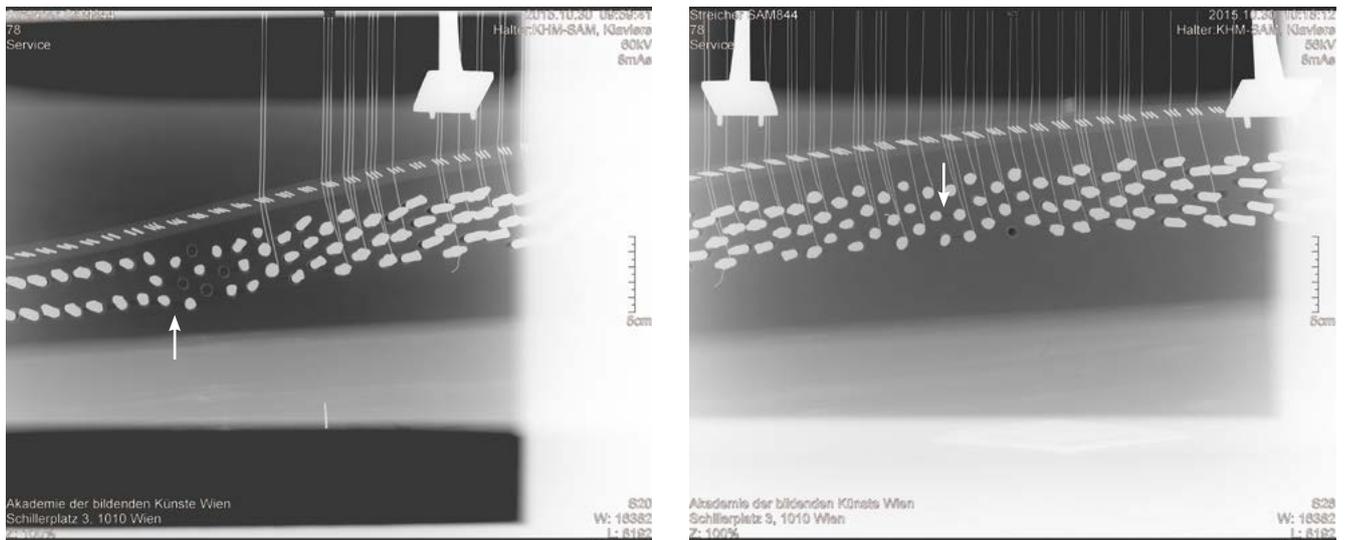
Fig. 11: X-radiographs of the wrest plank identified a crack. (Photo: Manfred Schreiner, Academy of Fine Arts Vienna.)

Although there was initially no strong suspicion of a crack in the wrest plank for the Streicher piano, it was prophylactically decided to have an x-radiograph of the critical component made. Manfred Schreiner of the Academy of Fine Arts Vienna was commissioned to do this *in situ*. It was thus revealed that the wrest plank showed cracks of varying widths in multiple places. As to be expected the bass area, where the highest tensile forces occur, was most effected (*fig. 11*).

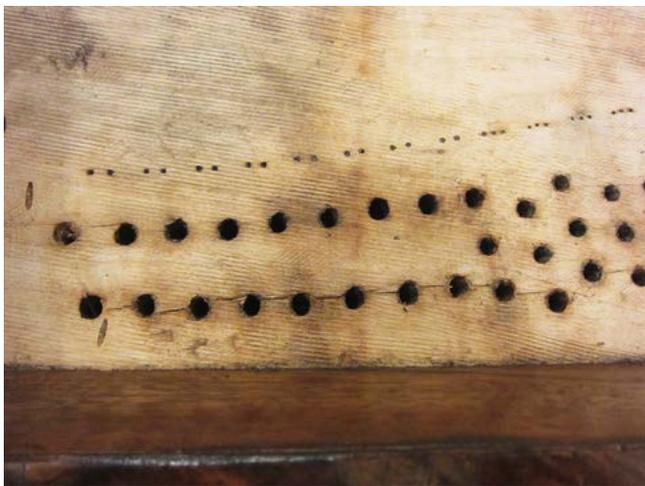
Fig. 12: The extent of the wrest plank crack was revealed on removal of the veneer.

Following the diploma thesis by Markus Brosig,⁴ which already seven years before had provided orientation in the restoration of the fortepiano by Johann Schantz, where the method discussed therein could be successfully realized,⁵ the decision was made unanimously with the collection curators to also repair the cracks with Araldite® epoxy resin in this case. After removal of the wrest plank bridge, the covering veneer could be removed with a minimum of damage using damp sponge cloths and an infrared heater, upon which the suspicion of a compound crack in the wrest plank was confirmed (*fig. 12*).

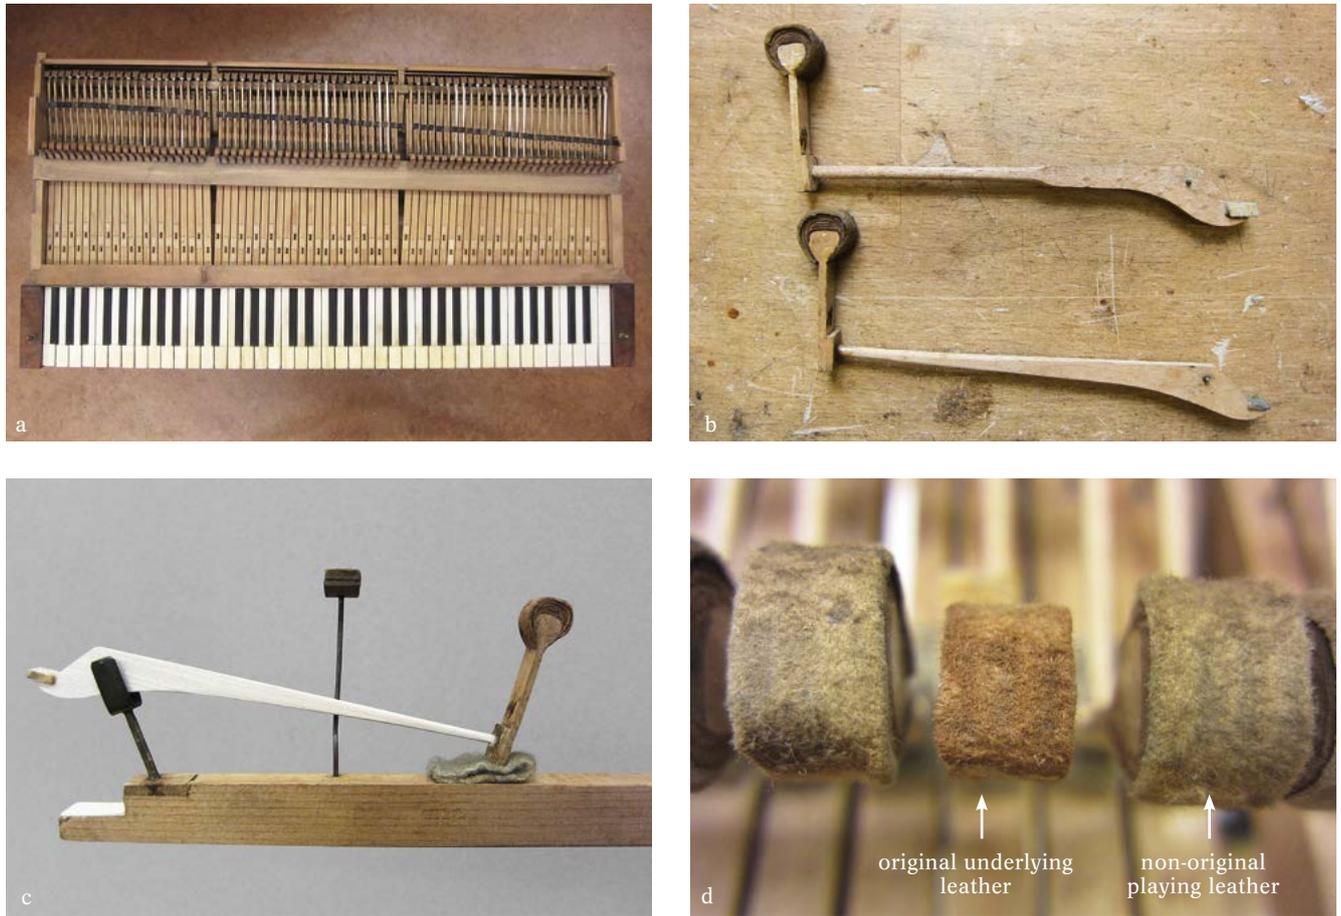
Fig. 14: Restoration of the action.

- a. Necessity of replacing eleven non-original hammer shanks.
- b. Comparison of original (below) and non-original (above) hammer shanks.
- c. Hammer shank reconstructed after the original.
- d. Comparison of original underlying leather and non-original playing leather.

Eleven non-original hammer shanks, which differed from the originals in form and material, had to be replaced in the mechanism (*figs. 14a and b*). The new hammer shanks were reconstructed following the original model (*fig. 14c*) and acoustically tuned to the neighbouring hammers through plucking and thinning, following the method discovered by Paul McNulty.⁶ The extant inhomogeneous intoning leather, that is, the uppermost leather layer on the hammerheads, obviously derived from later repairs on the basis of its appearance, thickness, tanning method, and quality of application (*fig. 14d*). In the search for the optimal striking points, it was revealed that multiple hammers became stuck on the front edge of the wrest plank due to the excessive thickness of the renewed leather in the descant. To solve this problem, it was decided to remove the non-original leather and attach a thin vegetable-tanned leather from the same animal (sheep) as a so-called ‘sacrificial layer’ to protect the original core leather. The adjustment and regulation of the mechanism alone – parallel to the breaking-in phase – required several weeks.

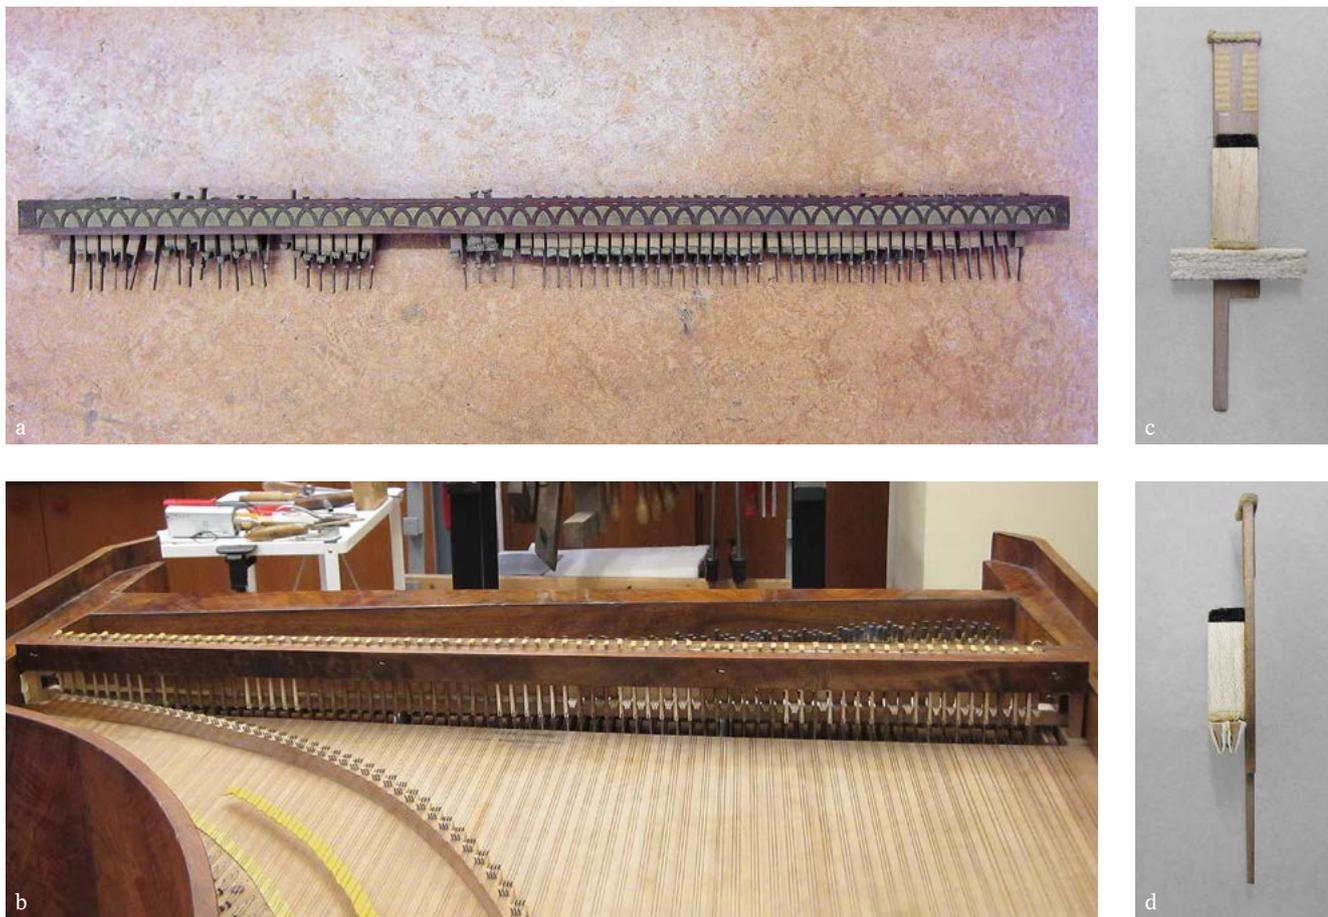
Fig. 15: Restoration of the damper.
 a. Condition before treatment.
 b. Replacement of missing pieces.
 c and d. Reconstructed wedge-shaped damper.

The damper action showed serious mechanical damages (*fig. 15a*). Numerous damper guiding rods and lost dampers had to be reconstructed, and finally the entire damper action in the instrument reconfigured (*figs. 15b to d*).

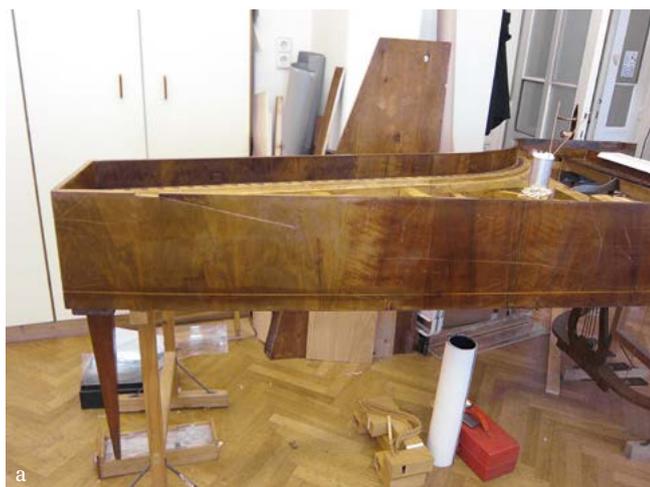
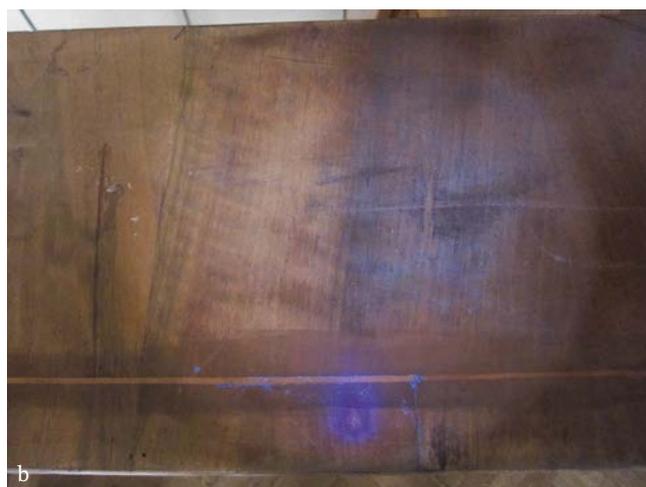
The veneer of the long wall had severe mechanical damage and showed numerous deep scratches, dents, and injuries to the lacquer. The different character of the veneer, differences in the colour of the lacquer, and a different wood structure of the marquetry suggested that the veneer in the last third of the long wall had been replaced (*fig. 17a*). The appearance of the replacement indicated a coating containing cellulose nitrate. Investigation under UV illumination confirmed this assumption through the observation of differing fluorescence at the interface of the two veneer types (*fig. 17b*). As the differences in colour were very disturbing, the colour of the repaired surface was matched to the original.

Fig. 17: Condition of the rear wall before treatment.
 a. Non-original veneer with recent lacquer.
 b. Differing fluorescence at the interface seen under UV light.

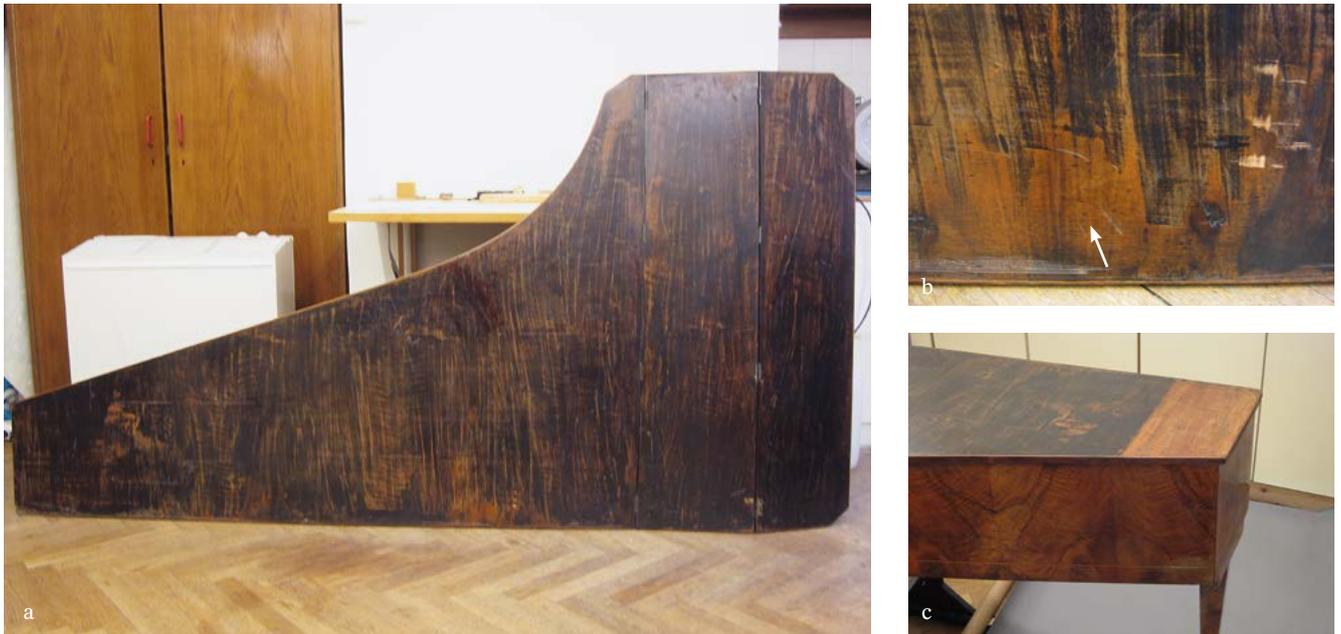
Fig. 19: Surface of the lid.

a. Condition before treatment with remains of the original lacquer.

b and c. Intermediate stage during removal of the overpaint.

The exterior of the lid had been carelessly overpainted at a later date with a dark brown lacquer, presumably pigmented with soot. The coating was so unaesthetic that at no point was there doubt about removing it rather than leaving it as an 'organic condition' (fig. 19). As the original lacquer was previously sanded off except for a small area, there was no concern about removing the black layer with solvents, which was easily achieved using a mixture of ethanol and acetone. To match the exposed veneer surface to the appearance of the adjacent original surfaces, a ground of toned modified linseed oil varnish was applied, and finally a mixed polish based on a contemporary recipe⁷ was put on with a pad.

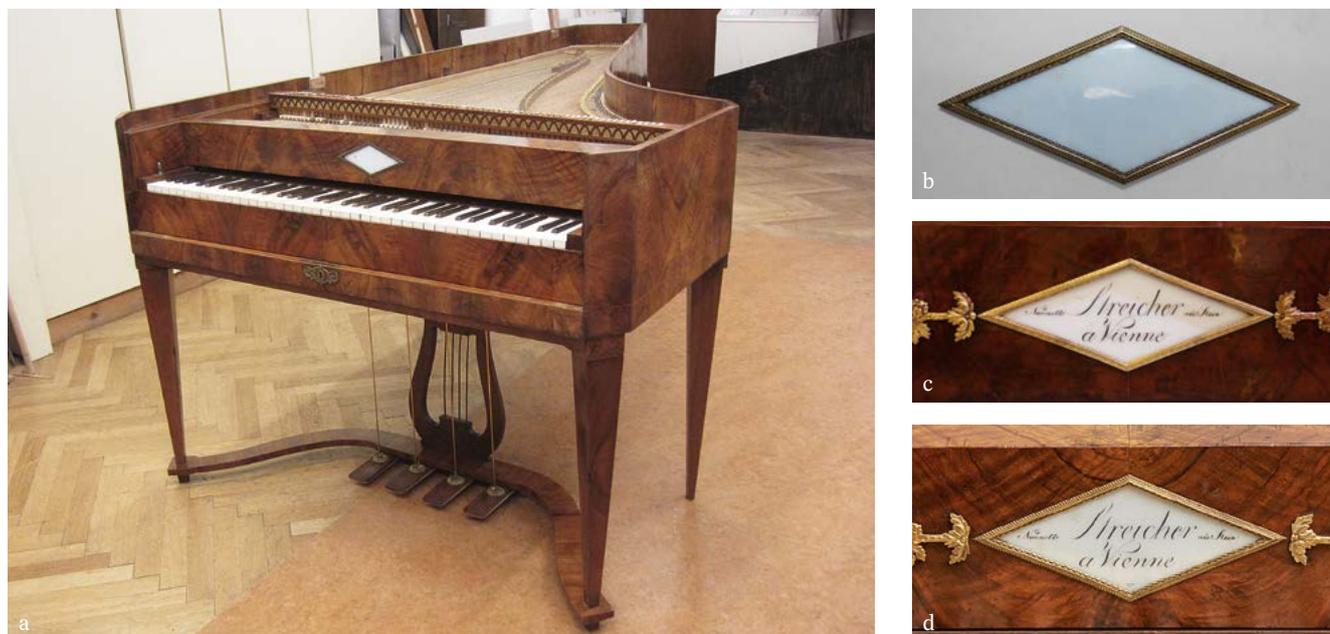
Fig. 20: Facsimile of the nameplate.

As the original nameplate over the keyboard was either replaced by a sheet of matte glass or the original ink signature had been effaced (figs. 20a and b), the decision was made to attach a reproduction plate to this prominent place. This was adjusted from the model in the Vienna Museum of Technology using Photoshop (fig. 20c) and – printed in reverse on a transparency – laid reversed on the glass in the original frame so that the lettering on the back of the transparency would be properly legible. The facsimile is indicated through a small dated annotation (fig. 20d).

a. Condition before treatment.

b. Matte glass without signature.

d. Signature facsimile on the old matte glass. (Photo: Rudolf Hopfner.)
