The Restoration of the Fortepiano by Nannette Streicher Opus 961, Vienna 1813 (SAM 844)

Ina Hoheisel and Alfons Huber

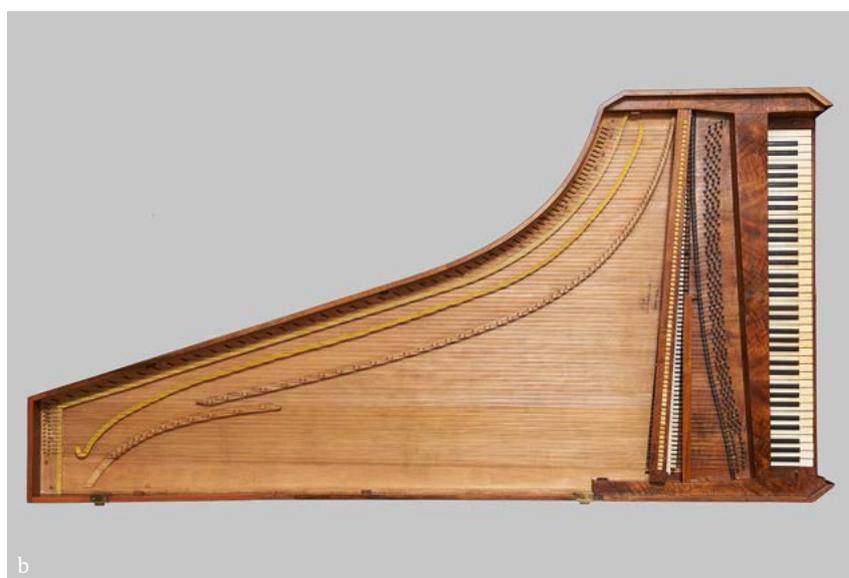
Figs. 1a and b: Fortepiano by Nannette Streicher, Vienna 1813, after restoration. Vienna, Kunsthistorisches Museum, Collection of Historic Musical Instruments, inv. no. SAM 844.

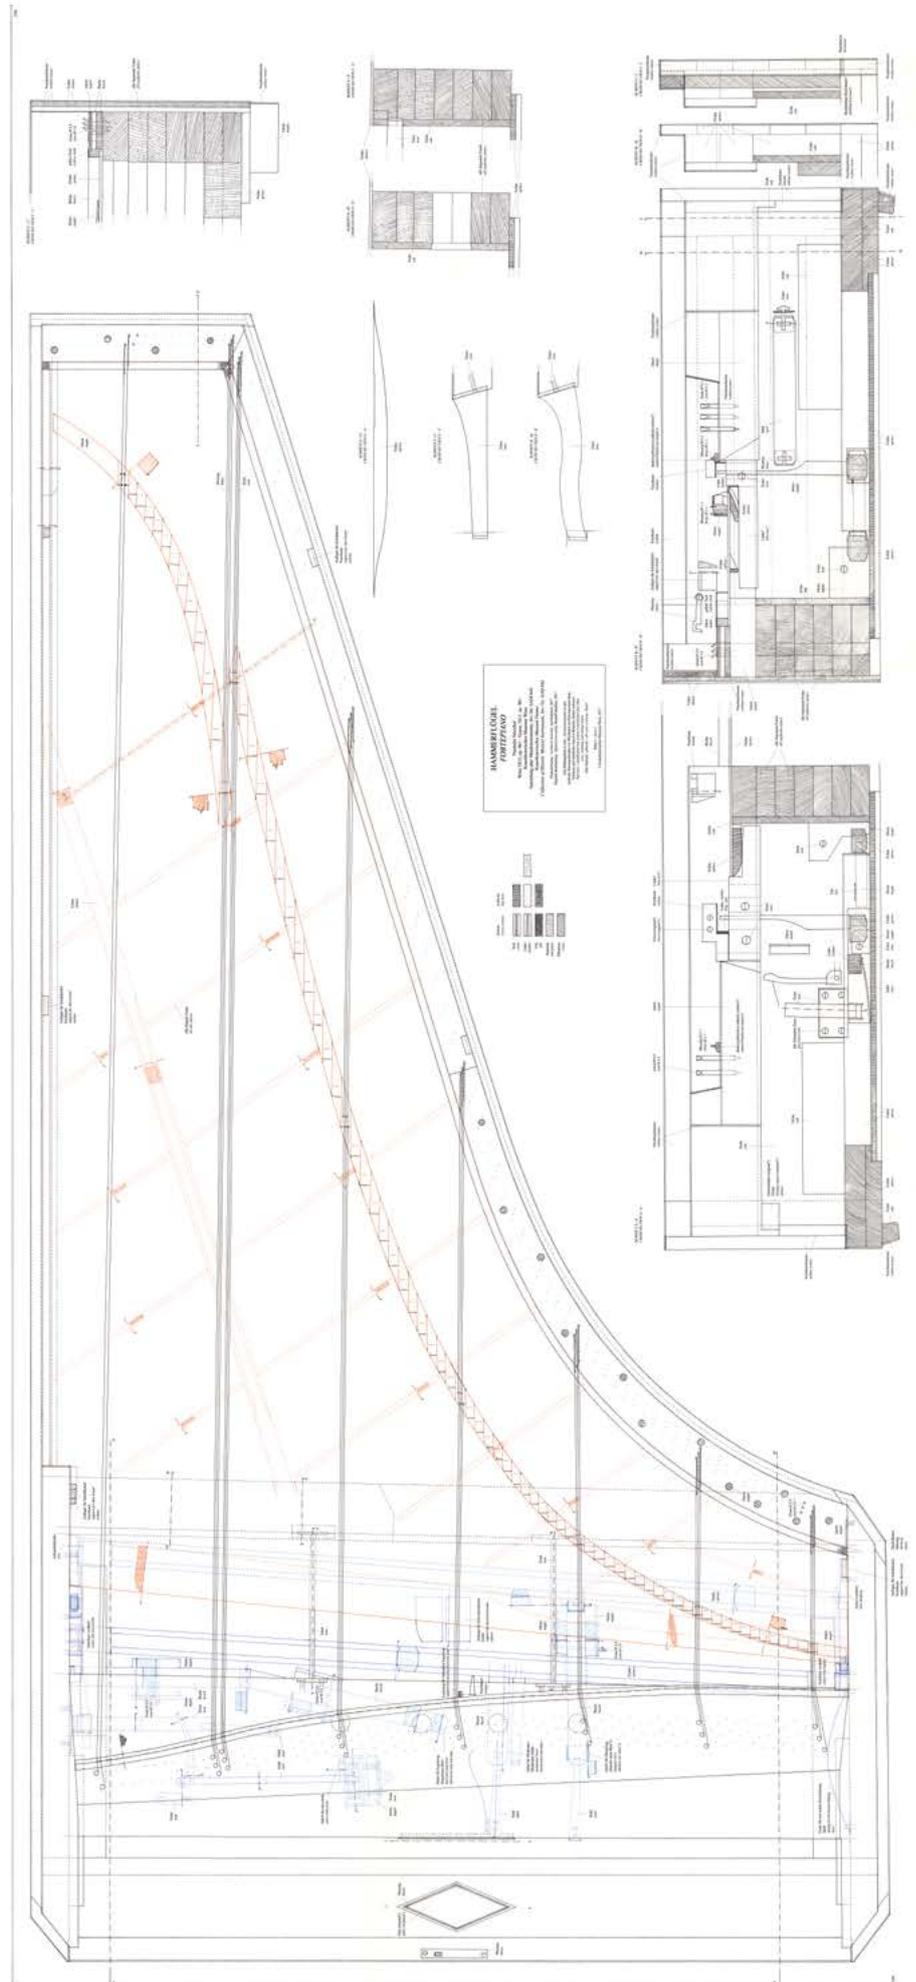
Figs. 4a and b: Technical drawing.

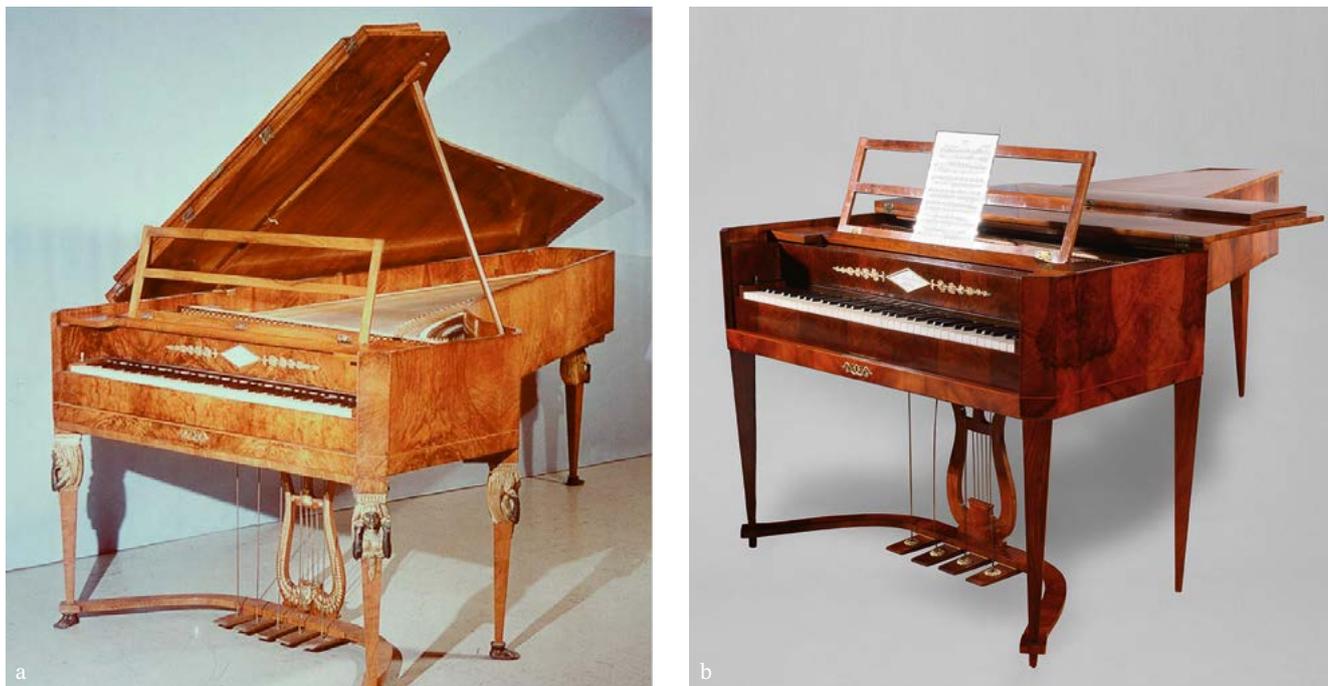
Fig. 7: Comparison instruments for the reconstruction of the pedal bridge.

a. Fortepiano Nannette Streicher, Vienna 1814. Stockholm, Swedish Museum of Performing Arts, inv. no. F332. (© Image by Sofi Sykfont, Swedish Museum of Performing Art. <https://creativecommons.org/licenses/by-nc-sa/4.0/>).

surface was aged and bore traces of use, and thus matched the overall appearance of the instrument (*fig. 6*). The piano surely had a curved pedal bar originally. Two sibling instruments were found for comparison, in the Swedish Museum of Performing Arts in Stockholm from 1814 (*fig. 7a*) and the Vienna Museum of Technology from 1819 (*fig. 7b*). Two facts are evident from these comparison instruments:

The veneering of the pedal bar likewise occurred using the detached veneer with its aged surface including traces of use. The reconstruction of all missing pieces was done following the Stockholm model, the feet and all of the brass decorations were oriented on the Streicher piano in the Vienna Museum of Technology. Moulding and casting of the brass appliquéés was done by the metal restorer Martin Klobassa.

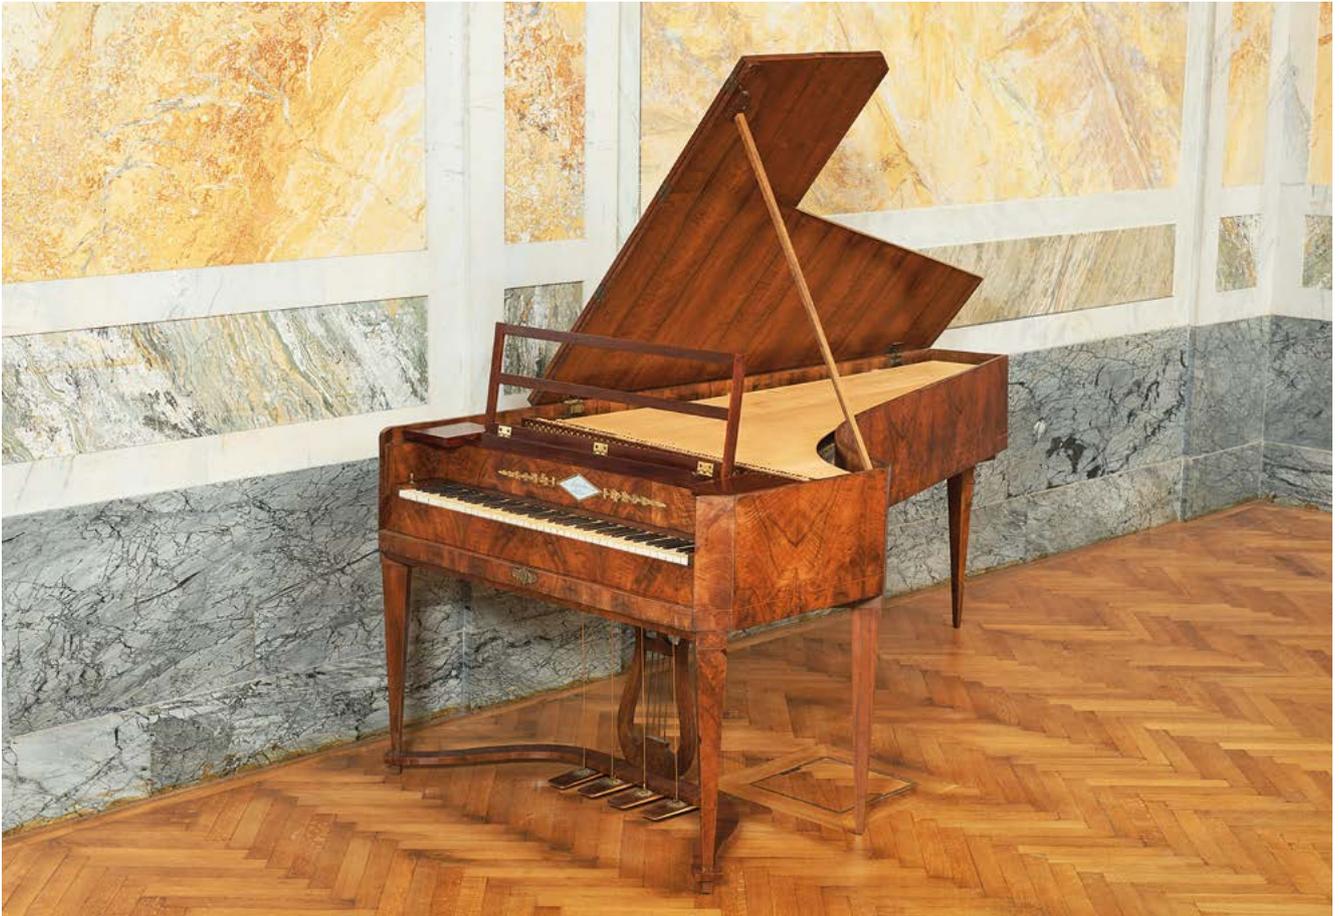
Fig. 21: Condition after treatment with reconstructed pedal system and soundboard.

Not least, since September 2016 many musician friends made their time available during the adjustment phase. This feedback played a decisive role in the development of the sound potential of the finished instrument (*fig. 21*). The pianist Birgit Streicher, additionally a direct descendent of the builder, gave us the most time.
